ENVIROTUBES®

A Geotextile Tube

A Step-By-Step for **Tube Repair**

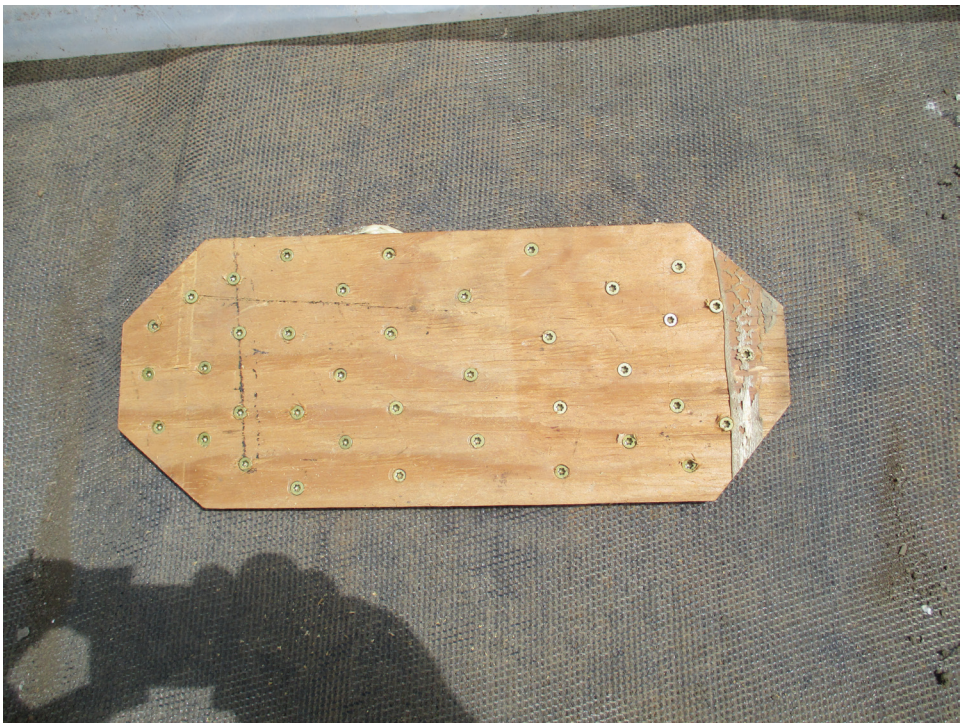
Step 9:

Placing the outside patch.

Press firmly.
